“ ELIMINATION OF REPETITIVE THRUST BEARING FAILURES ON A PROCESS AIR COMPRESSOR”

BY : M. M. PITKAR

**RELIANCE INDUSTRIES LIMITED, PATALGANGA
INDIA**

**35TH TURBOMACHINERY SYMPOSIUM' 2006
THE TEXAS A & M UNIVERSITY SYSTEM**

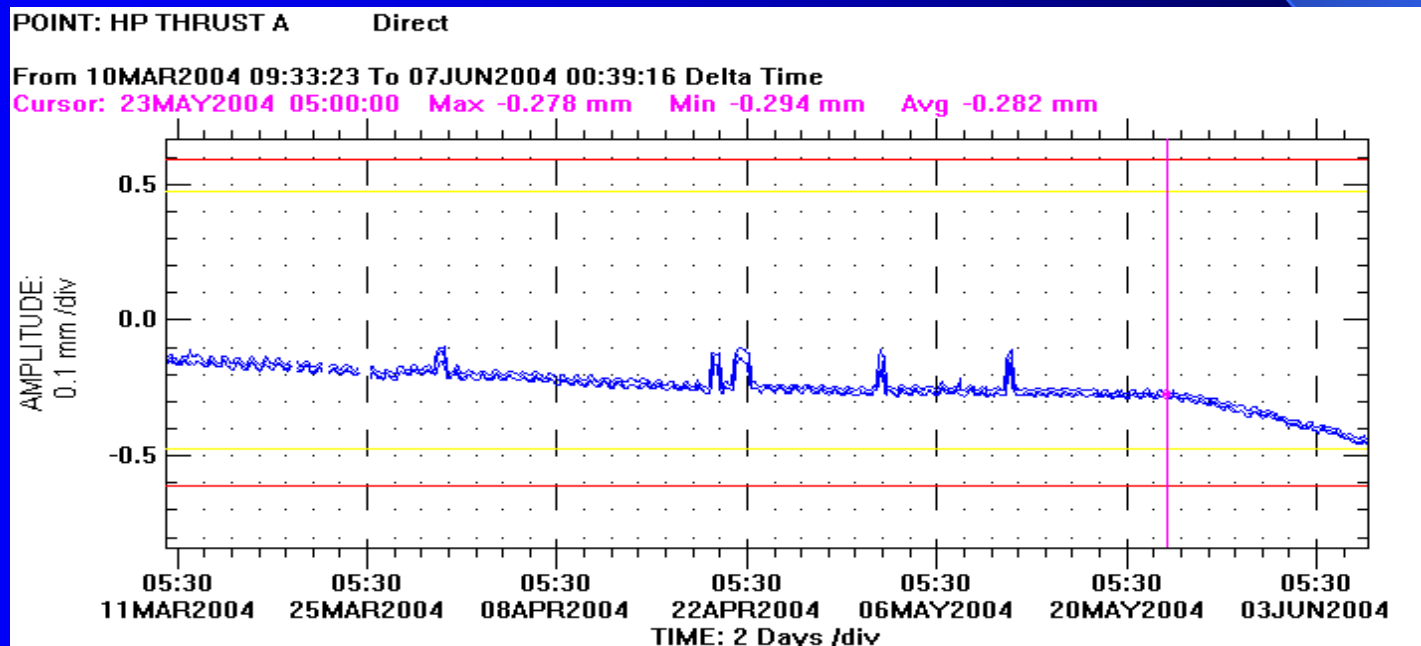
- ❖ HP Compressor active side thrust bearing was replaced during the annual shutdown (Jan'2004), as severe pitting was found on its pads .
- ❖ 5 months thereafter, increasing trend with a sharp spurt, observed in the axial displacement of the HP compressor.

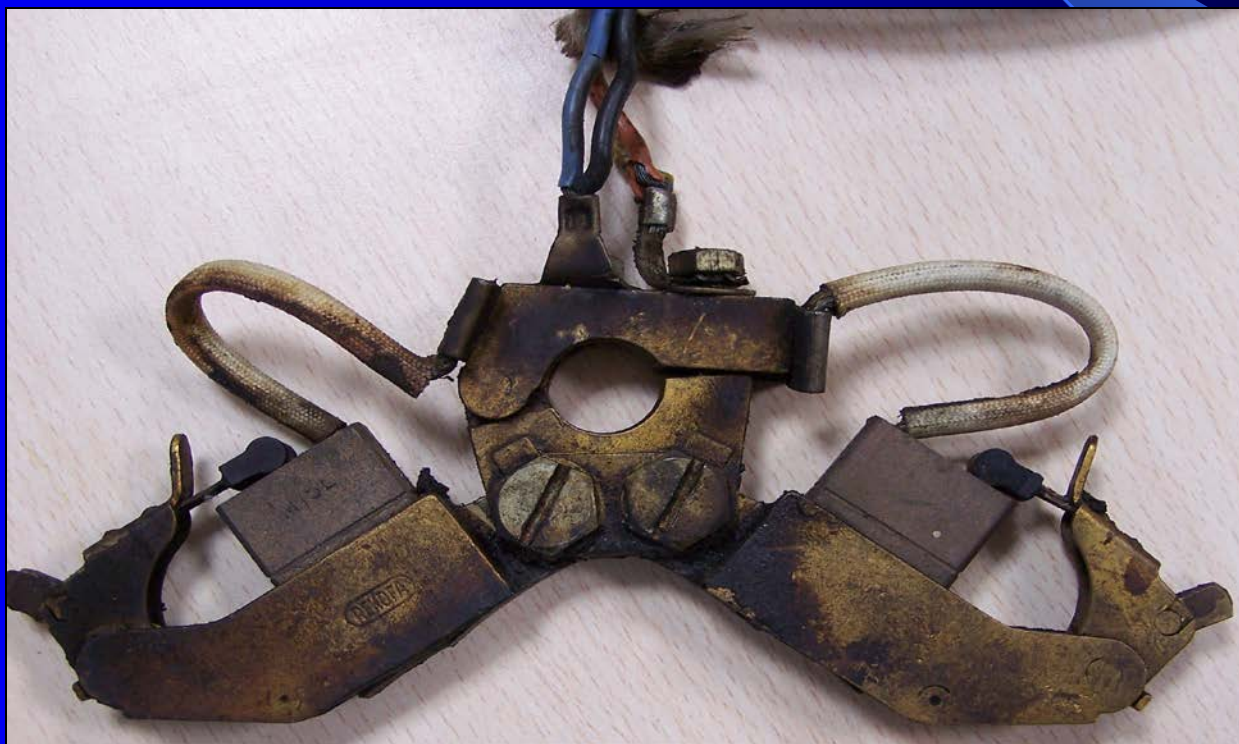
- ❖ Shaft grounding brushes worn out & jammed in the carrier.

- ❖ Active side Bearing replaced with new one.
- ❖ Brush carrier thoroughly cleaned & brushes made free.
- ❖ Axial float adjusted to **0.2 mm (7.87 mils)**.
- ❖ Machine boxed up and taken in line. **All parameters found normal.**
- ❖ Axial displacement recorded to be **- 0.18 mm (-7.08 mils)** { as against **- 0.46mm (-18.11 mils)** at the time of **Shutdown** }
- ❖ **1mA** current was measured at earthing terminal.

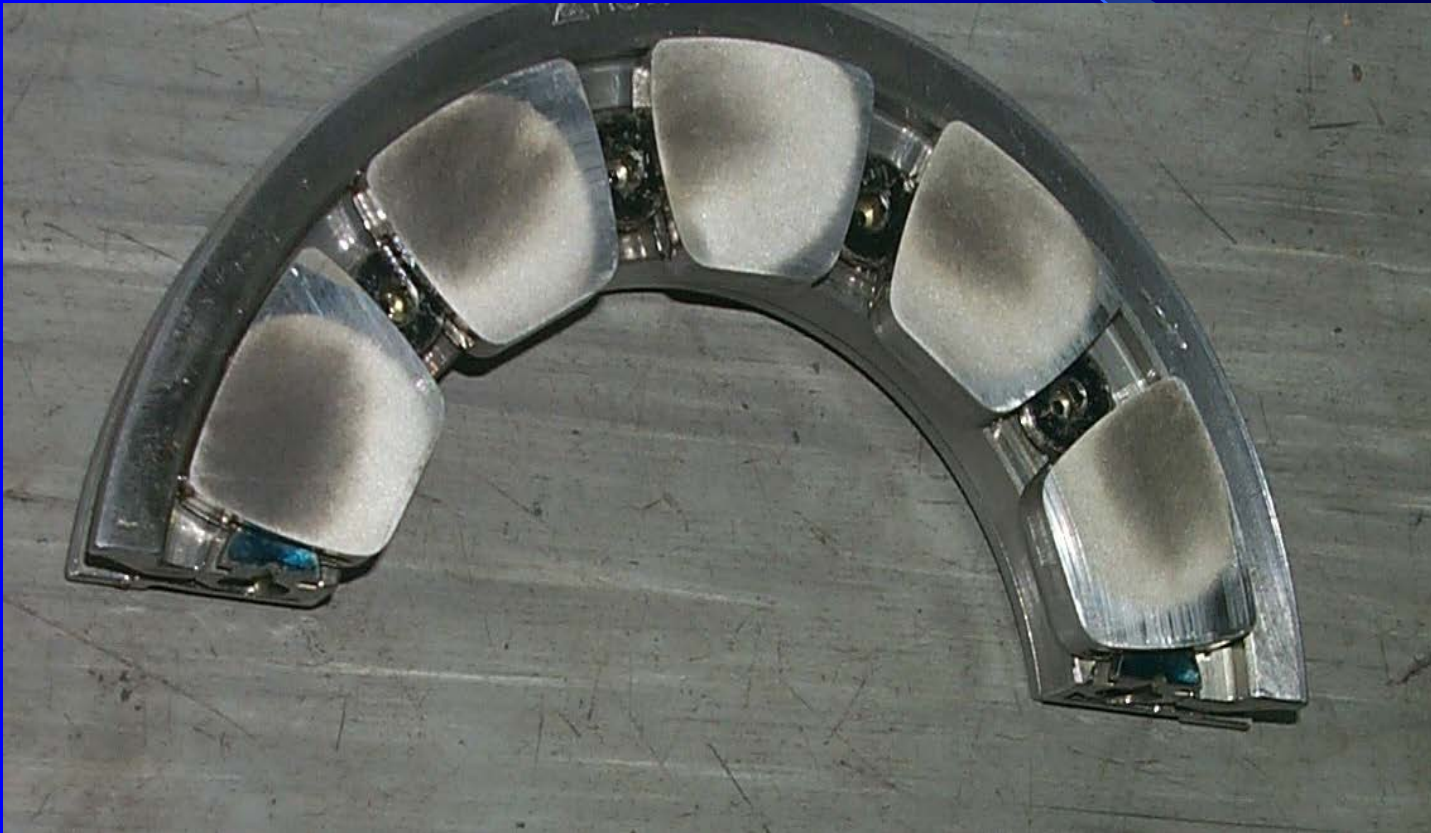
- ❖ Uniform wear out & “**Frosting**” marks along with oil varnishing observed on Active Thrust bearing pads .

- ❖ Wear out of **0.35mm (13.77 mils)** observed in the active side pads.
- ❖ **No Abnormality or Wear** in the inactive side bearing .

- ❖ In condensing turbines the last stages are subjected to saturated steam.
- ❖ The brushing effect of the water droplets (condensate) across the blades results in development of an electrostatic charge that builds up on the rotor.
- ❖ Charge periodically discharges to the ground through the path of least resistance.
- ❖ Dissipation of rotor voltage across an oil film bearing produces microscopic pits, resulting in loss of babbit, giving it a “**Frosted**”

appearance. Local overheating due to spark results in **Varnishing** of the oil.

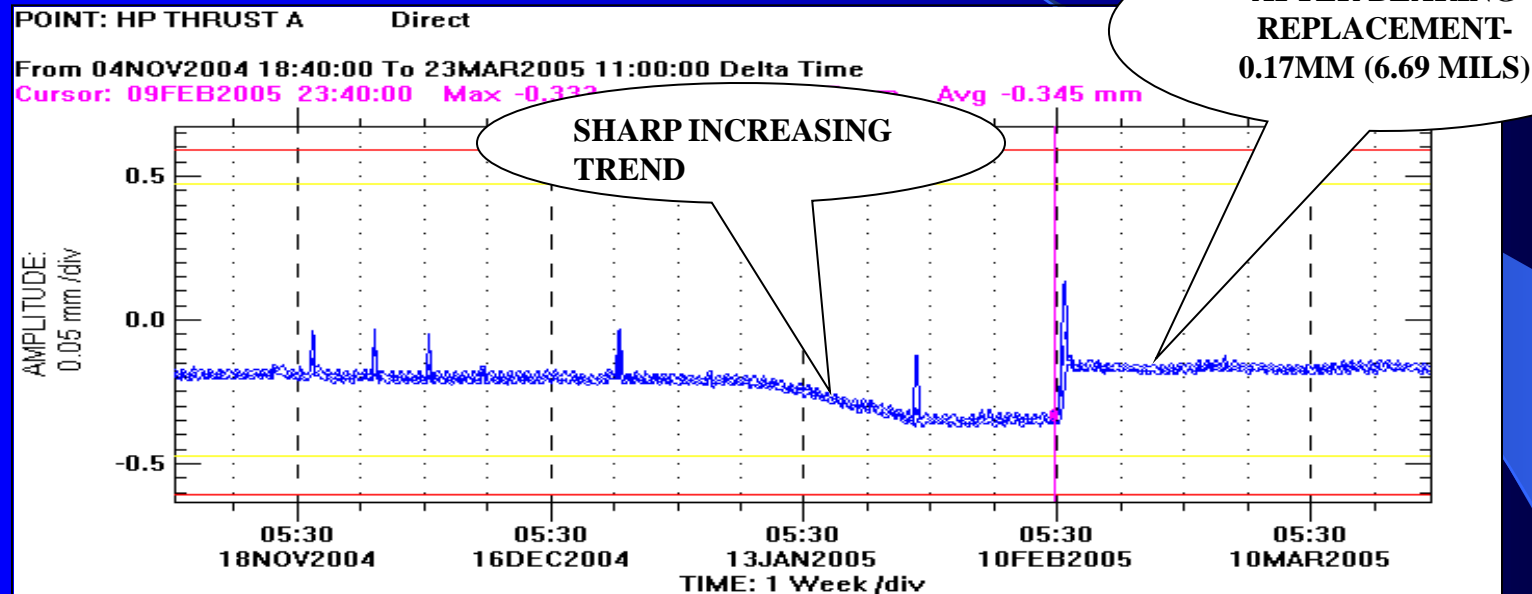
- Similar increasing trend with a sharp spurt, observed in the axial displacement.

- Observations similar to the earlier failure were made during the planned shutdown .
 - Carbon brushes “gummed-up” or jammed.
 - “Frosting” with pad thickness reduction.

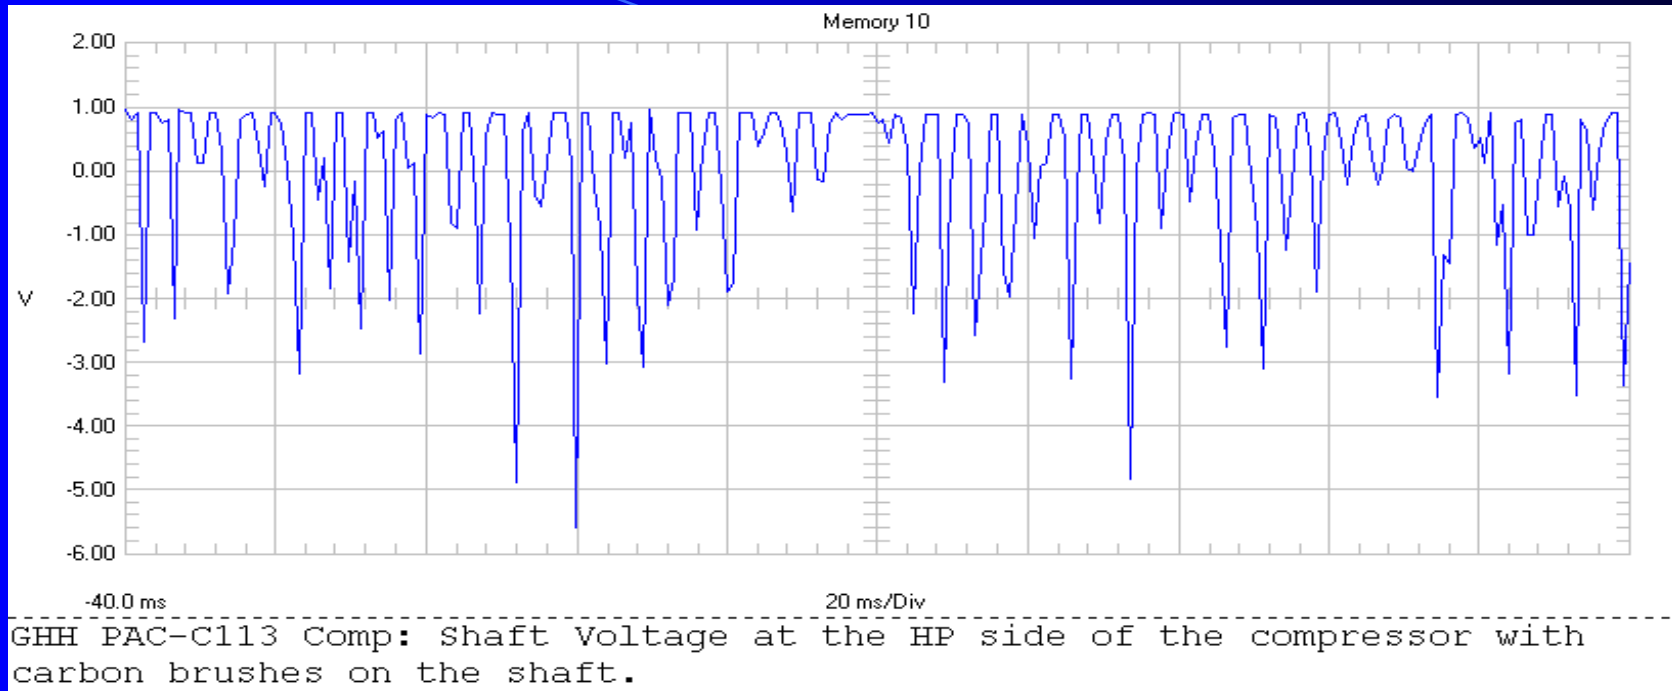
SHAFT VOLTAGE TRACES WITH CARBON BRUSHES

- ❖ Traces taken with Flukescope meter & portable gold plated brush, adjacent to the respective carbon brushes.
- ❖ Shaft voltage of 6V pk-pk was measured between the HP compressor and gearbox

Carbon brushes were ineffective in reducing potential between shaft and bearings, on that specific shaft, to below 50mV.

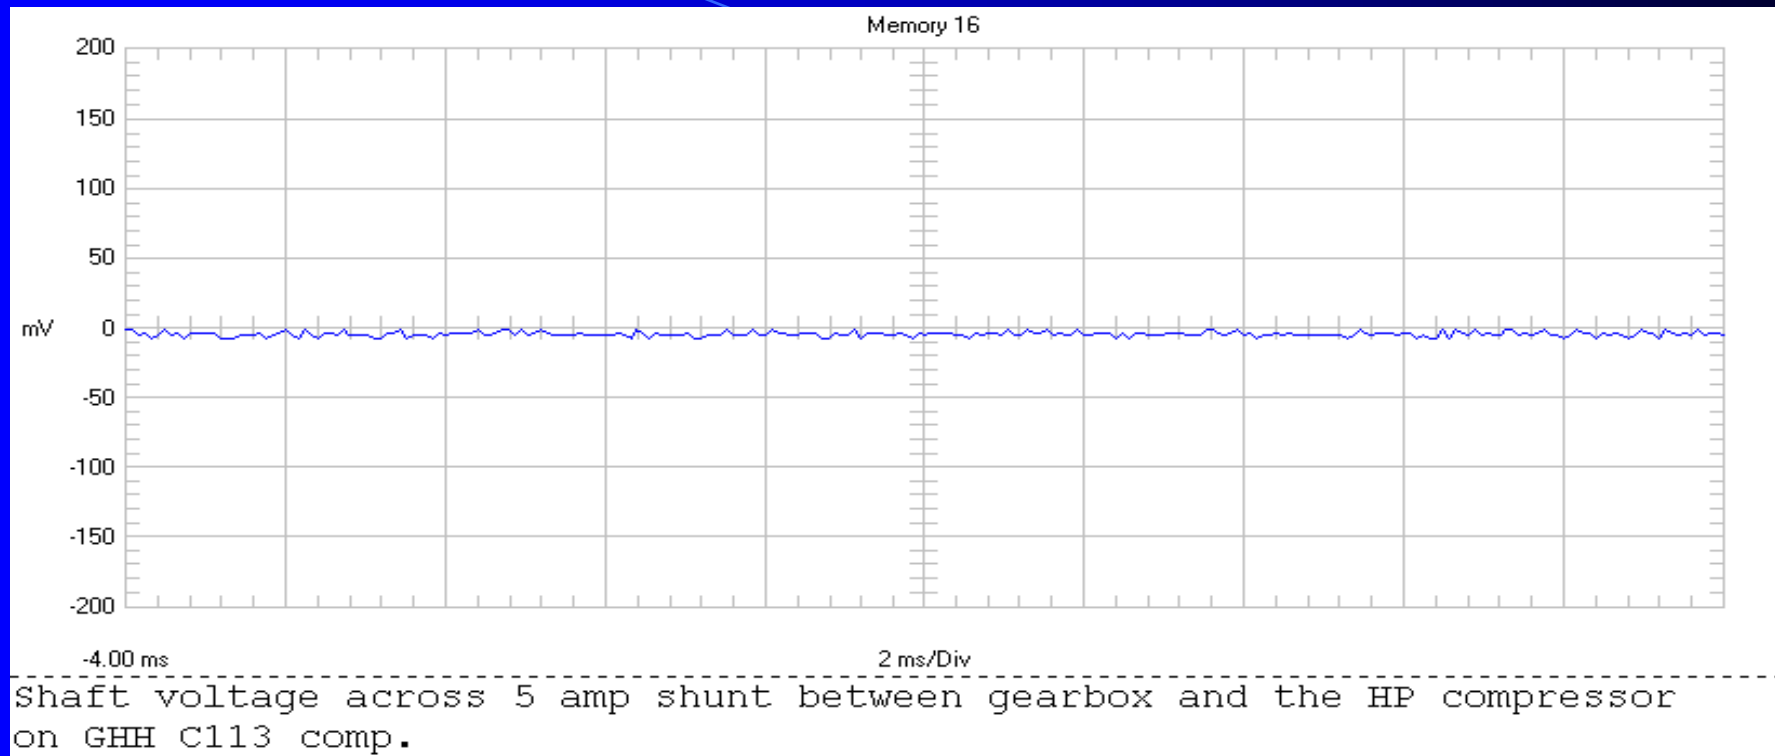
SHAFT VOLTAGE TRACE WITH NEW BRUSHES

- ❖ Voltage traces taken across 5A shunts at different brush locations with the brushes connected to the ground to determine the shaft current.
- ❖ Shaft voltages dropped to below 50mV with a current flow of approx. 0.2A

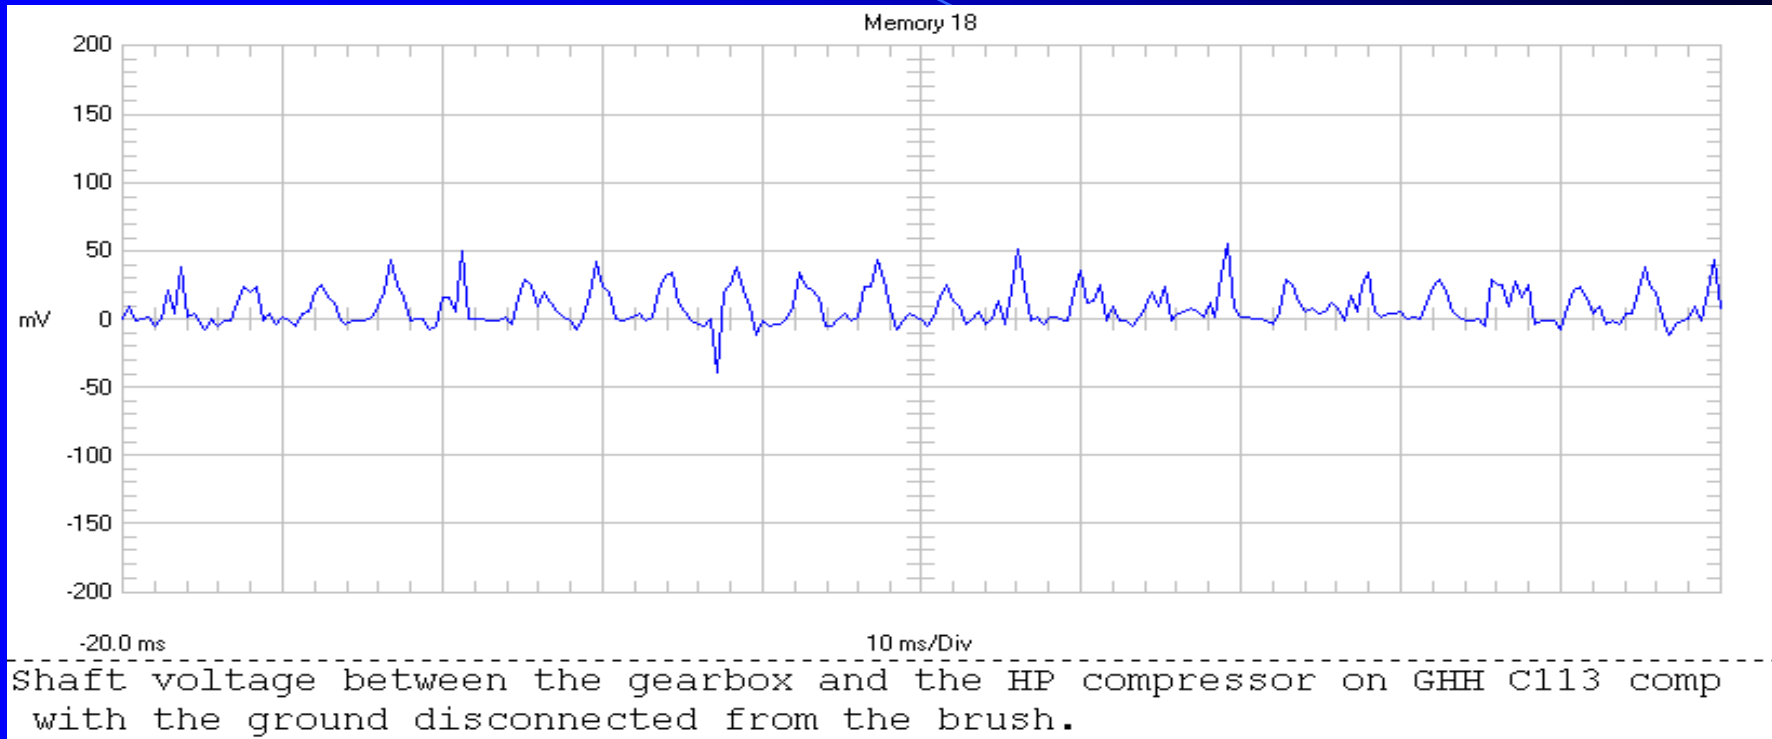
SHAFT VOLTAGE TRACE WITH ONE BRUSH DISCONNECTED

❖ Shaft voltage spikes below 50mV were generated, probably due to some residual magnetism.
